**Laguna Honda Hospital and
Rehabilitation Center**

**SAN FRANCISCO
Department of Public Health**

Rehabilitation Services Department

The Tree Allee ramp is a highly visible project leading to what is planned to be a state-of-the-art facility. As this is the sole "accessible" path of travel for mobility-impaired individuals, it is incumbent upon Laguna Honda Hospital and Rehabilitation Center and its Replacement Project to give thoughtful consideration to recommendations made in this report.

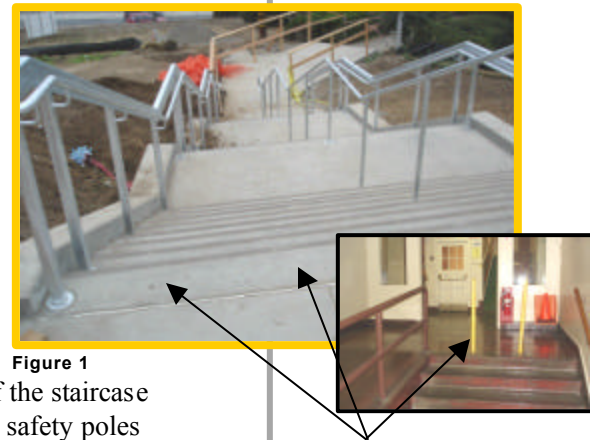
Figure 1

The staircase descending the hill to the Forest Hill MUNI station poses a potential danger to residents and visitors using wheelchairs. Although handrails have been installed on both sides, and in the center, of the staircase, a variety of wheelchairs could easily roll down the steps, endangering the wheelchair occupant.

While paragraph 4.9.6 of *Pocket Guide to the ADAAG* indicates that “detectable warnings”¹² at stairs is “reserved” — possibly for further consideration in a future update — we recommend that for people with low vision or visual impairments, that a high contrast 24” detectable warning be placed on the landing at the top of the staircase leading to the Forest Hill MUNI station.

Recommendation 1:

Install poles as safety barriers at the top of the staircase between the center and outer handrail, as is done on staircases in the Main Building. Space safety poles no more than 20” apart.

Recommendation 2:

Install a high contrast detectable warning strip on the landing at the top of the staircase.

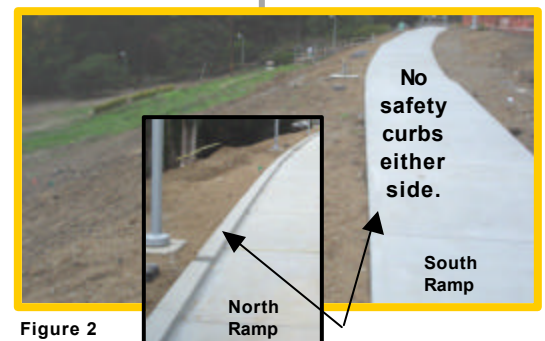
Figure 2

Our understanding is that there will either be railings or a curb at every section of the ramp where there is a potential for dropping off of an embankment (i.e., a continuous barrier). The only exception to this appears to be the transition between the railing and the curb at the curve of the South Ramp where it runs parallel to the South Road. There appears to be no protective barrier at the landing in this area. We recommend extending either the curb from the upper portion of the ramp or the handrails from the lower portion of the ramp to provide a protective barrier that is continuous.

Recommendation 3:

Extend either the curb from the upper portion of the ramp or the handrails from the lower portion of the ramp to provide a protective barrier that is continuous at the transition between the railing and the curb at the curve of the South Ramp where it runs parallel to the South Road.

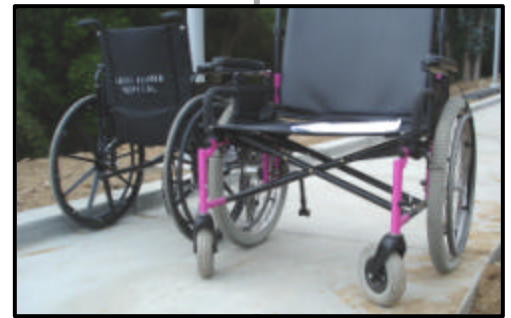
Note the minimal amount of space between the chairs, and the amount of space to the edge of the ramp in Figure 4.

Some electric wheelchairs are almost as wide as the bariatric wheelchair in Figure 4; one electric bariatric wheelchair in use at LHH is 31-1/2" from handrim to handrim.

Another hypothetical case would be a wheelchair like the bariatric one in Figure 4 trying to pass a blind person ambulating with a long cane who is being assisted by a human guide (i.e., a group of three people); the blind person, the human guide, or a guide dog, would be forced to step off of the ramp.

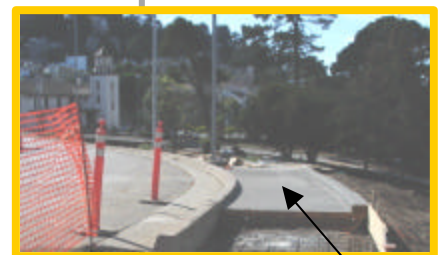
The section of the South Ramp just south of the staircase shown in Figure 5 that has safety curbs on both sides of the ramp measures only 65-1/2" wide. Two wheelchair users passing in opposite directions are going to have difficulty passing each other in this area. Using the two wheelchairs shown in Figure 4 they will be short at least 3-1/2". Only one wheelchair at a time will be able to navigate through this area. It could be hazardous for a wheelchair user to attempt backing up to an area wide enough to permit the two chairs to pass each other.

If handrails are installed in the section shown in Figure 5 and overhang into the 65-½" pedestrian area of the ramp, they will infringe on the passing space even more.

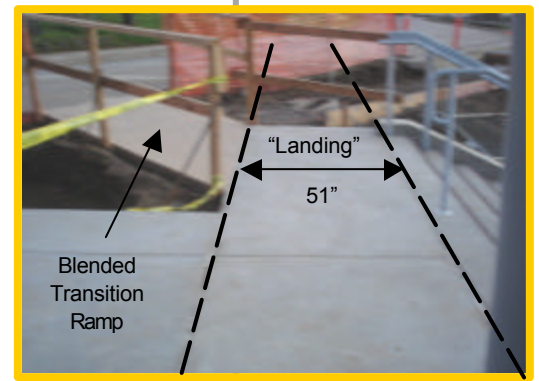
Although construction of the area shown in Figure 6 of the sidewalk is not yet complete, it appears that wheelchair users who use the blended transition to move from the crosswalk crossing West Clarendon Road onto the Tree Allee ramp may not have the required 60" flat landing area clear space in front of the top step of the staircase, as required by paragraph 4.8.4 of the *Pocket Guide to the ADAAG*, since it is only 51" wide.

Therefore, we recommend modifying the design to increase the landing at the top of the staircase to 60" wide, shortening the blended transition ramp from West Clarendon Road, as necessary.

We recommend placing a detectable warning surface on both ends of the blended transition ramp.

Recommendation 4:
 Modify the design specs to increase the landing at the top of the staircase to 60" wide, shortening the blended transition ramp from West Clarendon Road, as necessary.

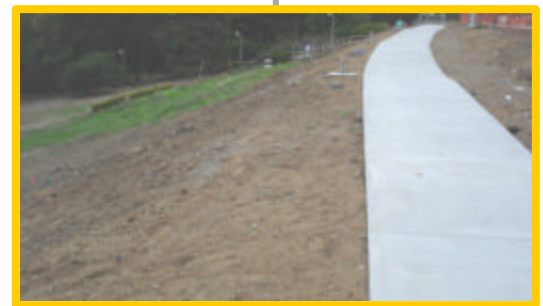
Figure 7

The *ADAAG* requires that right-of-way passing spaces should be placed every 200 feet for walks and sidewalks less than 60" wide¹³. Paragraph A4.2.1(3) of the *Pocket Guide to the ADAAG* notes that "almost all wheelchair users and those who use walking aids can also manage within this 32-inch width for *short distances* [emphasis added]." The guidelines do not address passing and resting areas for those who are traveling *long distances*; the length of the Tree Allee ramp between the sidewalk at Laguna Honda Boulevard and the end of the ramp before crossing West Clarendon Road is estimated to be 880'. This is a long distance, even for able bodied pedestrians to travel without a place to sit and rest. Therefore, we recommend placing benches (similar in design to those that will be used in the Rehabilitation multi-surface training area) along the Tree Allee ramp every 200', starting at Laguna Honda Boulevard. The benches should not have an overhang that protrudes into the ramp area.

Recommendation 5:
 Place benches (similar in design to those that will be used in the Rehabilitation multi-surface training area) along the Tree Allee ramp every 200'. Consideration should be given to creating — at minimum — three turnout areas along the Tree Allee.

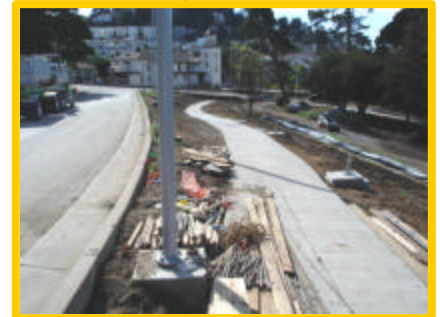
If the handrails are mounted on the surface of the Tree Allee ramp on both sides in the manner they are mounted on the staircase, the 72" width of the ramp will be reduced by 15", leaving only 57" for two wheelchairs to pass one another, which would prove unacceptable because *long sections of the Tree Allee ramp in Figure 8 would not permit two wheelchairs going in opposite directions to pass one another.*

Consideration should be given to creating — at minimum — three right-of-way turn out areas along the Tree Allee. These should be considered additional right-of-way passing areas/turn outs measuring at least 60" x 78" (in order to perform a U-Turn safely in a right-of-way area off of the walk); they should be completely flat and should include the recommended benches placed off of the ramp and off of the turnout area for people ambulating with the help of a human guide, guide dog, or cane, or simply for people who may need to sit and rest part way up or down the hill. Although not required by code, consider installing a water fountain midway up the hill; this would be a very welcome addition.

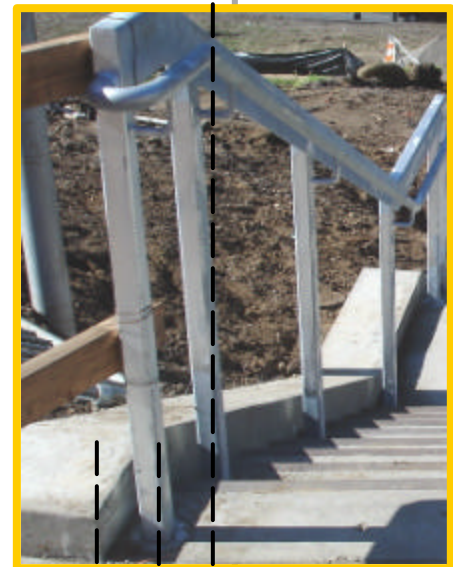
4" | 3-1/2" | Figure 9
7-1/2"

If the handrails planned for installation on both sides of some sections of the Tree Allee are installed as they are on the staircase, there may be an infringement of up to 15".

As shown in Figure 9, the space between outer edge of the steps and the inner side of the handrail posts measures 4". The space between the inner side of the post to the inner side of the actual handrail adds another 3-1/2" for a total of 7-1/2".

We recommend that mounting the handrails off of the Tree Allee ramp in order to avoid infringement of the 72" "pedestrian area."

Recommendation 7:
Mount handrails off of the Tree Allee ramp in order to avoid infringement of the 72" "pedestrian area."

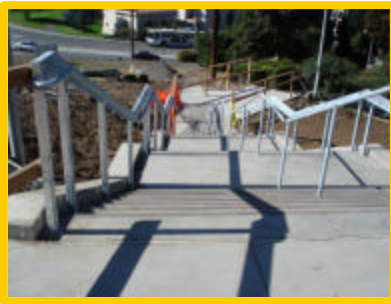
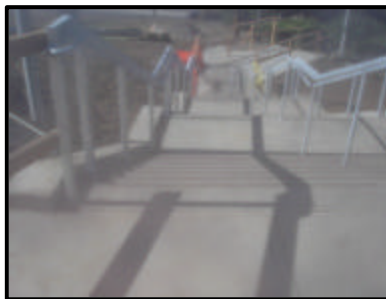
We are concerned about safety for LHH residents, staff, and visitors who have low vision or other visual impairments at the top of the staircase leading down the hill to the Forest Hill MUNI station. As shown in the insets accompanying Figure 10 taken with low vision simulators, people with low vision or other visual impairments are going to have trouble seeing the striping on each of the treads on the staircase due to insufficient contrast.

How Figure 10 appears to someone with low vision as a sequela of mild cataracts.

How Figure 10 appears to someone with low vision as a sequela of moderate/severe cataracts or diabetes.

We recommend adding high contrast detectable warning striping on each tread, if possible. This could likely be provided with a high contrasting textured paint or concrete.

Recommendation 8:
We recommend adding high contrast detectable warning striping on the first step, and on each tread, if possible.

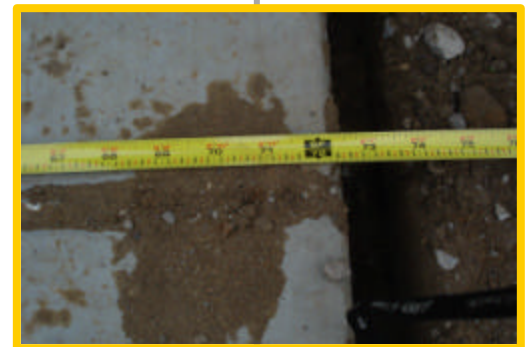
Figure 11

Although the majority of the ADA ramp on the lower hill is mostly at least 72" wide, as shown in Figure 12, we recommend including safety curbs on both sides of the design for the ADA ramp on the Upper Hill (leading from the front entrance of the Main Hospital to the bottom of the Upper Hill), noting that the distance between both curbs be consistently designed to a width of 78", and also incorporate other recommendations (e.g., resting benches, handrails, etc.) made in this report.

We recommend a 78" width for the following reason: A person was measured in a 26-1/2" standard wheelchair propelling the wheels; the abduction of the arms of this average person measured from elbow to elbow was 34" when propelling the wheelchair; however, some wheelchair users may propel with a greater abduction of their arms. Two standard wheelchairs passing each other would need 68". On a 72"-wide ramp, this leaves only 4" of clearance between the chairs and each side of the ramp (e.g., 2" between the chairs, and 1" on each side of the ramp). Increasing the width by 6" to 78" would provide a more reasonable 10" of space, allowing the chairs to pass without getting too close to the edge of the ramp or walk and would afford a modicum of "personal space" for each wheelchair user.

Recommendation 9:
Include safety curbs on both sides of the design for the ADA ramp on the Upper Hill (leading from the front entrance of the Main Hospital to the bottom of the Upper Hill), noting that the distance between both curbs be consistently designed to a width of 78", and also incorporate other recommendations (e.g., resting benches, handrails, etc.) made in this report.
